A Brief Assessment of Project Actions envisaged for the LIFE Saving Buskett Project

Report on Actions C3, C4, and C5

ECOSERV REPORT REFERENCE : 075-15_R

June 2015

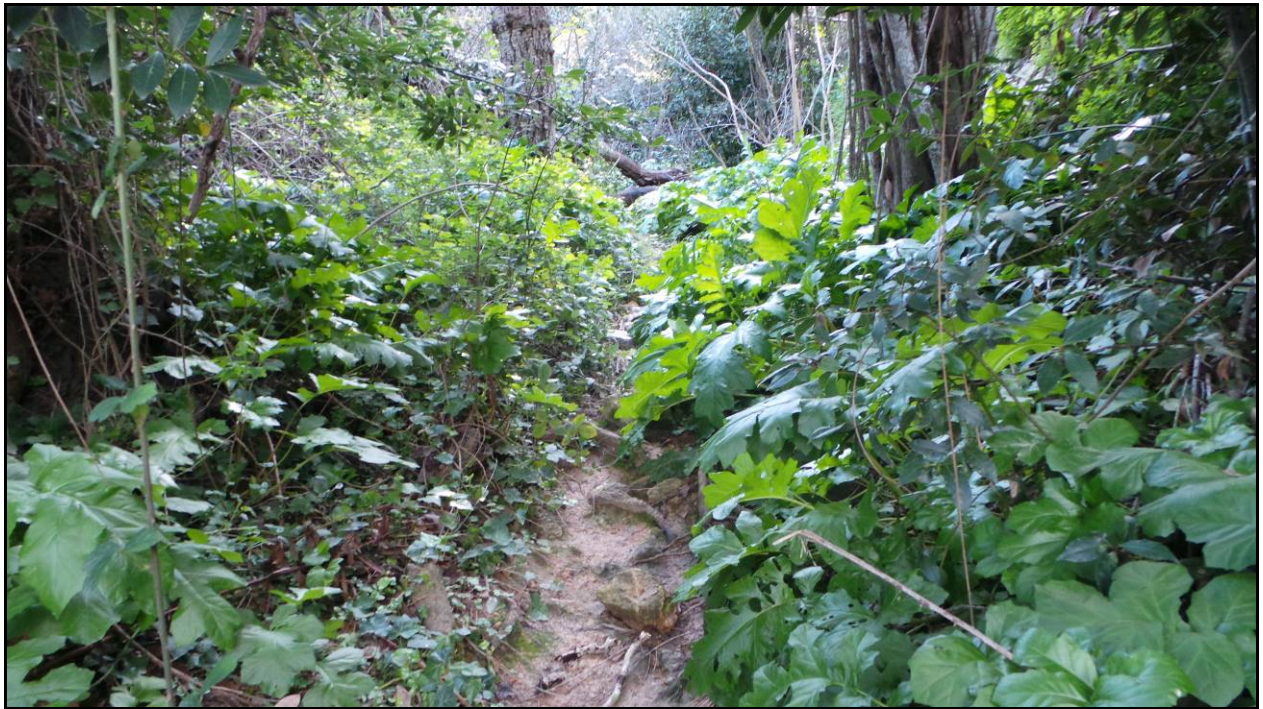
Figure 2: Part of the watercourse bed in the Western sector of the area of study. The dominant species is Bear's Breeches (*Acanthus mollis*).

The dominant vegetation colonizing the bed and margins of the watercourse varied along its length. Dominant species, in terms of biomass and abundance, in the western sectors of the bed (Figure 2) included Bear's Breeches (*Acanthus mollis*), Bramble (*Rubus ulmifolius*), and Alexanders (*Smyrniololus atrum*). Further eastward, vegetation along the bed was dominated by Clustered Dock (*Rumex conglomeratus*) in association with Goosegrass (*Galium aparine*), Italian Lords and Ladies (*Arum italicum*), and Friar's Cowl (*Arisarum vulgare*). The vegetation in these areas was characteristic of humid, shaded environments but not, in general, of a perennial aquatic habitat. The central portion of the watercourse (Figure 3, Figure 4) was characterised by relatively restricted patches of species requiring longer hydroperiods, including Lesser Celandine (*Ranunculus ficaria*), Scilly Buttercup (*Ranunculus muricatus*), Water Speedwell (*Veronica anagallis-aquatica*), and Pale Speedwell (*Veronica cymbalaria*). Small patches of Stinking iris (*Iris foetidissima*) and Sticky Fleabane (*Dittrichia viscosa*) were also noted along the banks of the watercourse in this area. The eastern sector of the watercourse bed was largely occupied by a monospecific bed of Great Reed (*Arundo donax*) (Figure 5).

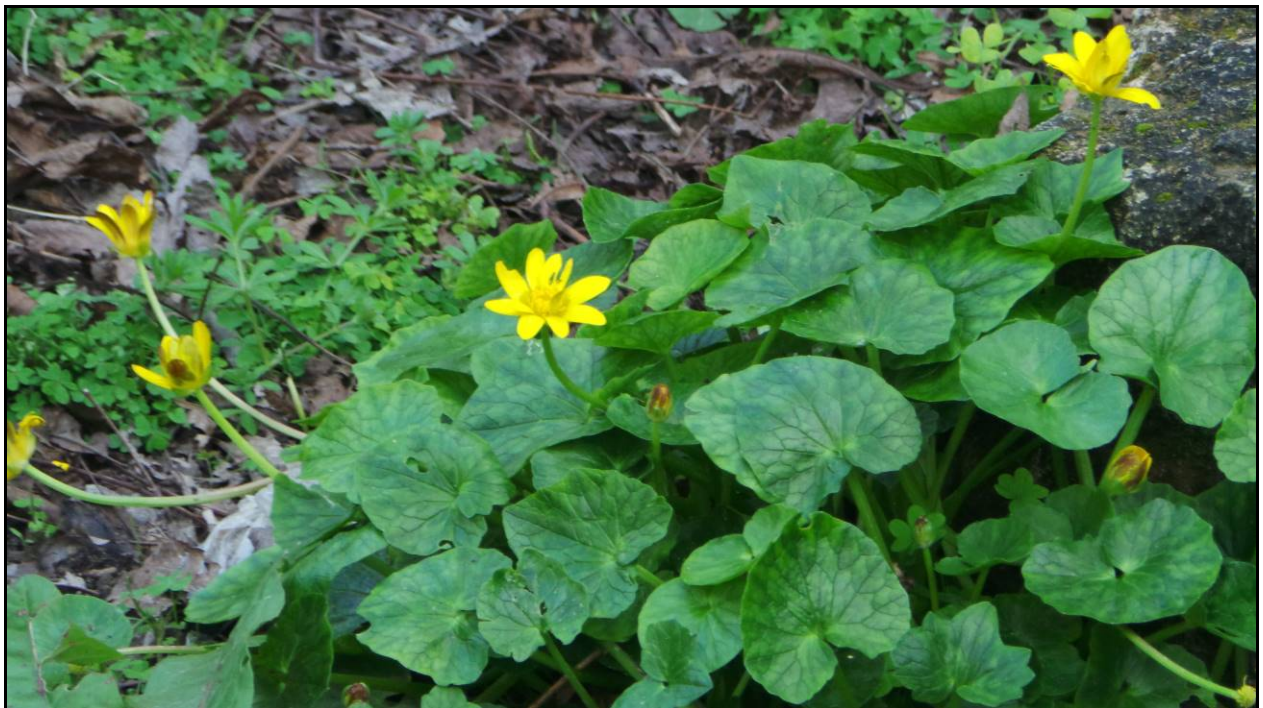
Figure 3: Lesser Celandine (*Ranunculus ficaria*) colonising the watercourse bed in the Western segment of the area of study.

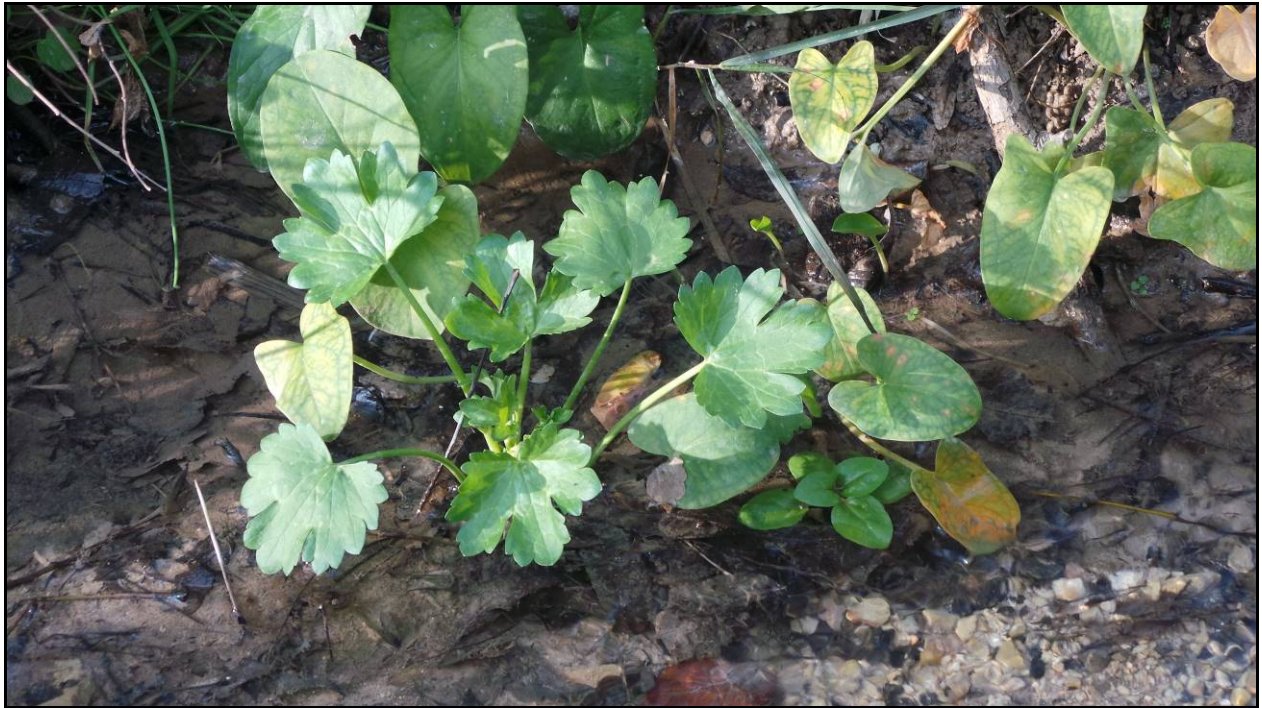
Figure 4: Part of the watercourse bed in the central segment of the area of study, showing Scilly Buttercup (*Ranunculus muricatus*), Water Speedwell (*Veronica anagallis-aquatica*) and Friar's Cowl (*Arisarum vulgare*).

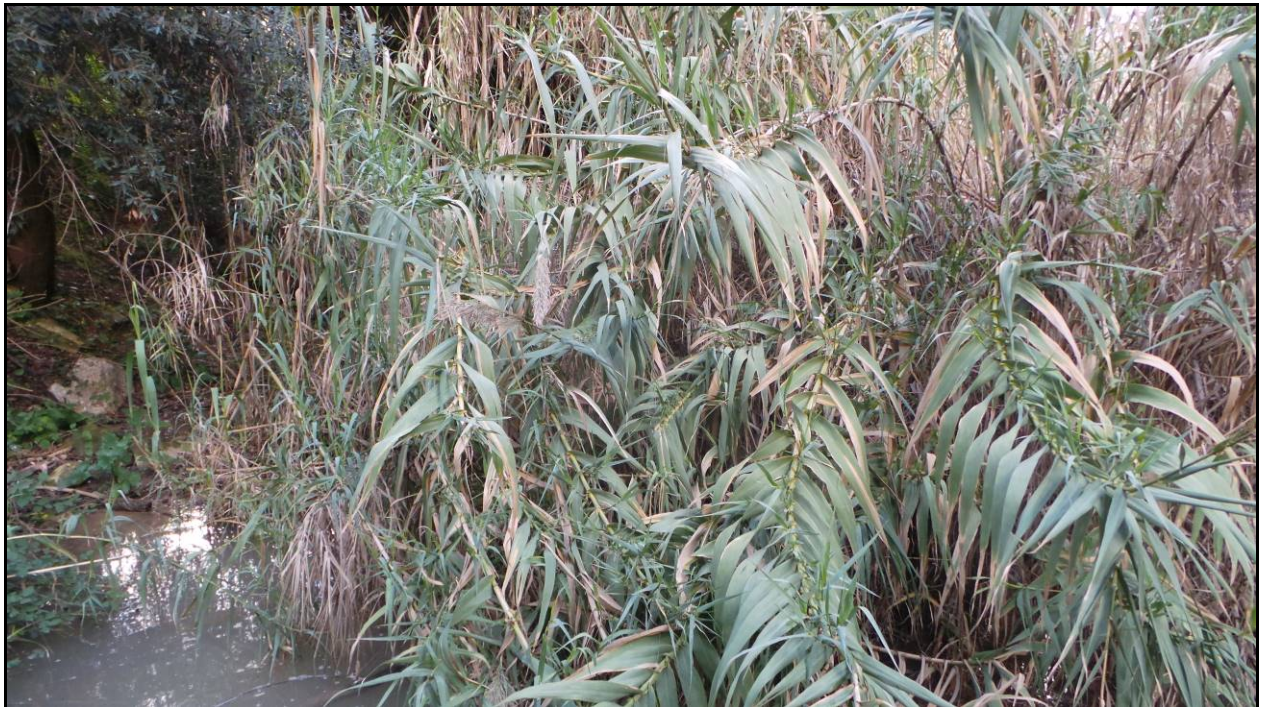
Figure 5: Dense, monospecific bed of Great Reed (*Arundo donax*) colonising the watercourse bed in the eastern segment of the area of study.

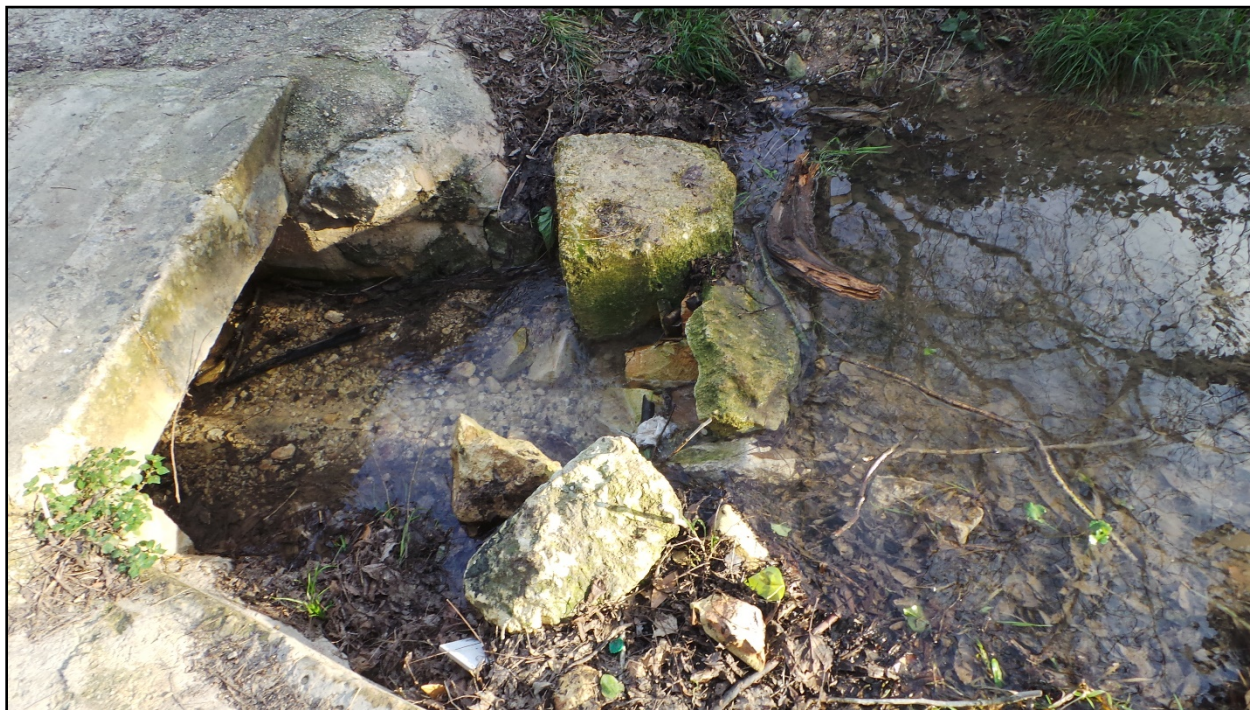
Throughout most of its surveyed length, the watercourse was reduced to a relatively narrow channel, seldom wider than 1-2m. In general, the immediate margins of the watercourse comprised compacted soil that was, in many places, consolidated by vegetation cover. Parts of the stream bed were partially obstructed by large pieces of masonry (Figure 6) that detached from surrounding structures (dry stone walls, etc). Much of this masonry was colonised by a surface covering of mosses, indicating a long residence time in the bed. A relatively unweathered (suggesting recent introduction) concrete building brick was also noted from the central segment of the watercourse (Figure 7). Although these blocks may obstruct water flow, their inclusion increases habitat diversity by creating smaller microhabitats that may provide refuge for stream-dwelling organisms. Some parts of the stream bed were also obstructed by large accumulations of dry twigs and branches (Figure 8). These accumulations were a relatively permeable barrier, and did not appear to provide a significant obstruction to water flow.

Figure 6: Blocks derived from fallen masonry in the watercourse bed. The blocks were characterised by surface coverings of mosses and microalgae.

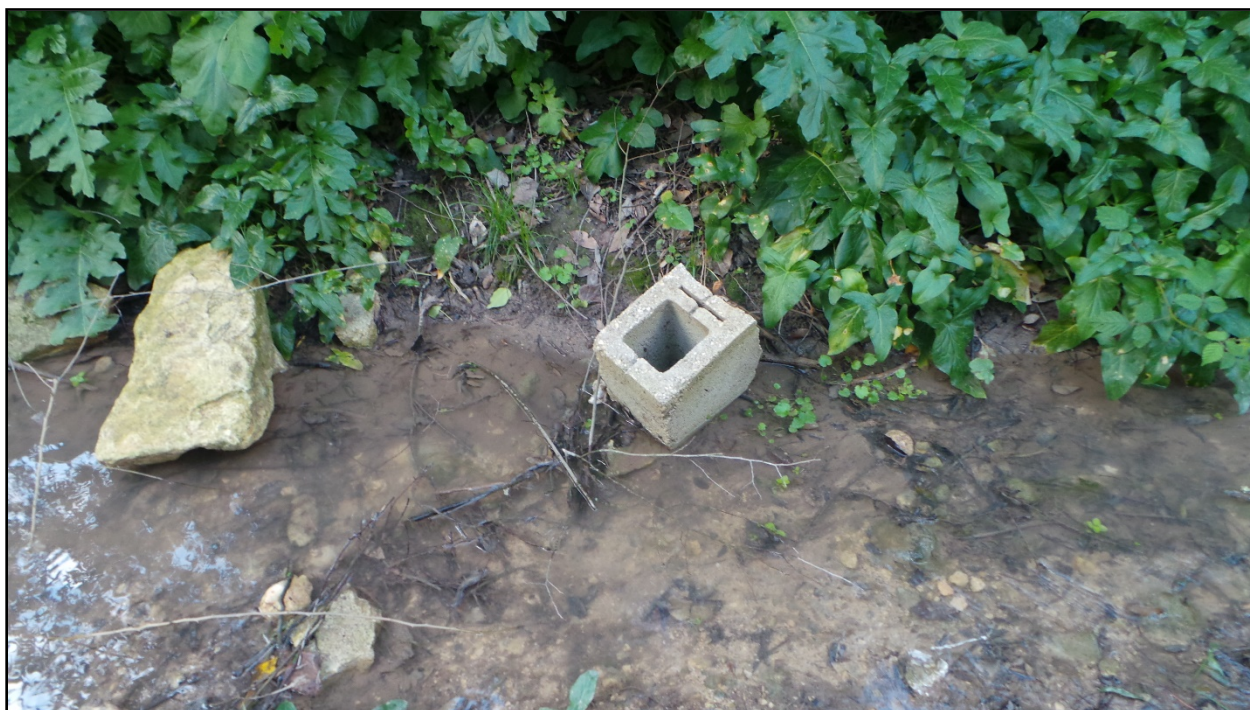
Figure 7: Relatively unweathered concrete building brick obstructing part of the central segment of the watercourse.

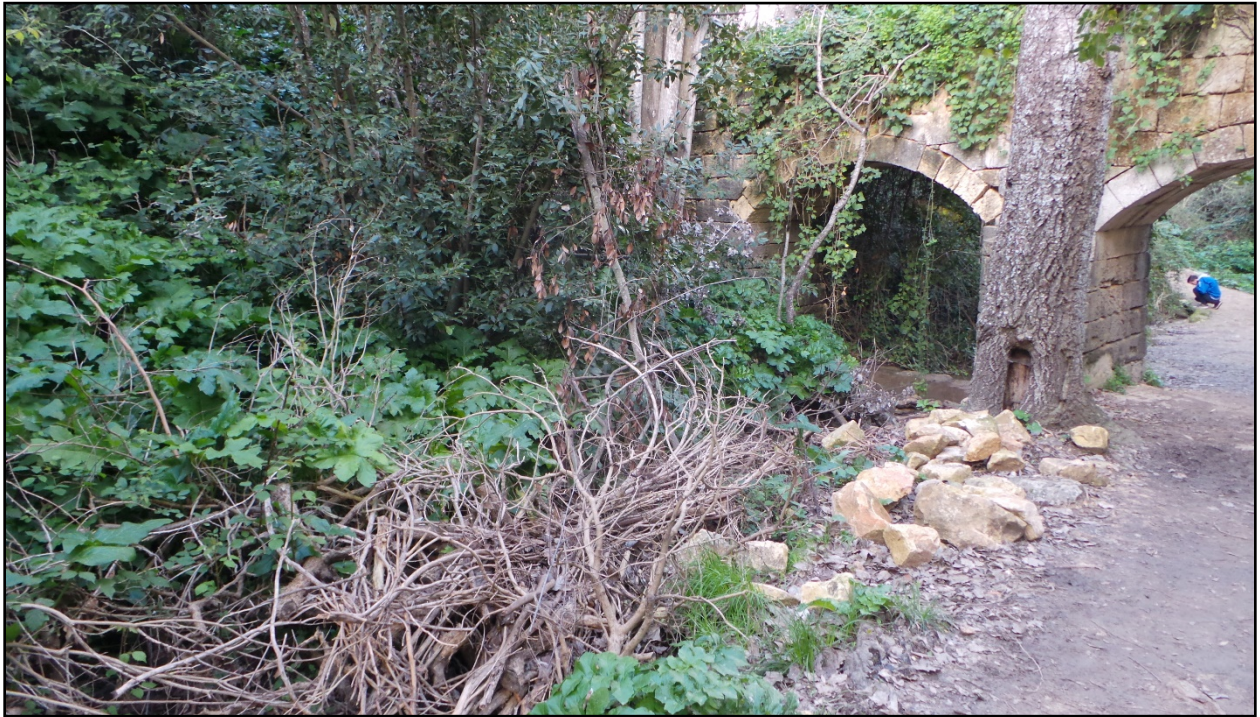
Figure 8: Accumulations of twigs obstructing the watercourse bed in the central segment of the area of study.

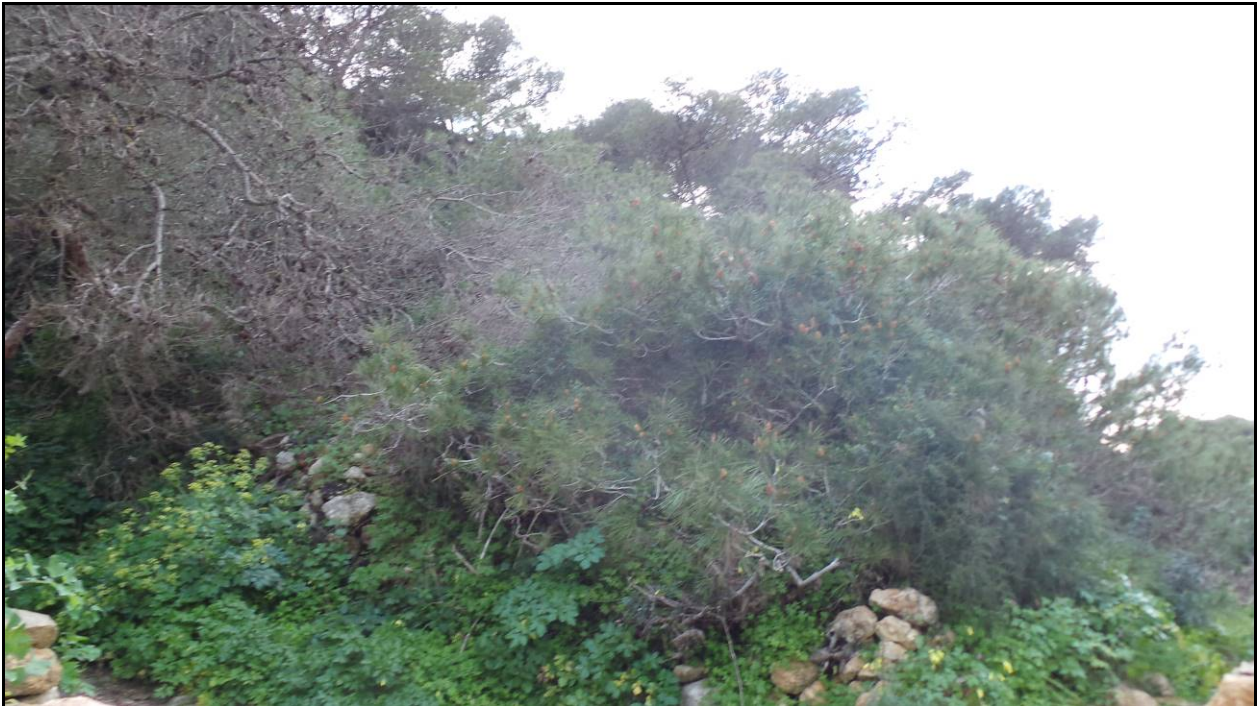
Figure 9: Wooded area designated for Action C4. Dominant species were Aleppo Pine (*Pinus halepensis*) and Cypress (*Cupressus sempervirens*).

The areas designated for Action C4 were generally colonised by open Mediterranean woodland (Figure 9) dominated by Aleppo Pine (*Pinus halepensis*) and Cypress (*Cupressus sempervirens*). Localised areas dominated by other species, particularly Olive (*Olea europaea*) and Laurel (*Laurus nobilis*) were noted (Figure 10). Small stands comprising species that are uncharacteristic of Mediterranean woodland, including *Araucaria heterophylla*, were noted. Undergrowth varied across the designated areas, and mainly consisted of Lentisk (*Pistacia lentiscus*), Hawthorn (*Crataegus* spp.), Honeysuckle (*Lonicera implexa*), Bear's Breeches (*Acanthus mollis*) and Alexanders (*Smyrniolum olusatrum*).

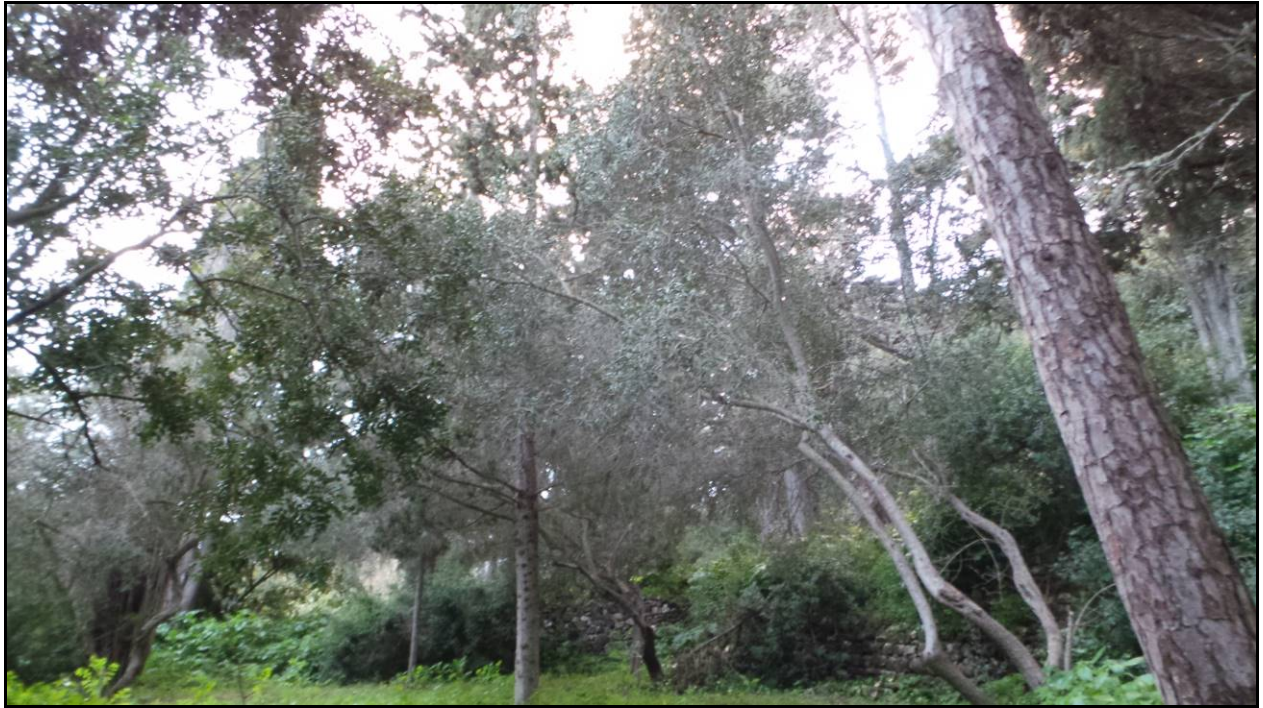
Figure 10: General view of a sector designated for Action C4 in the western segment of the area of study, Dominant species were Aleppo Pine (*Pinus halepensis*) and Olive (*Olea europaea*).

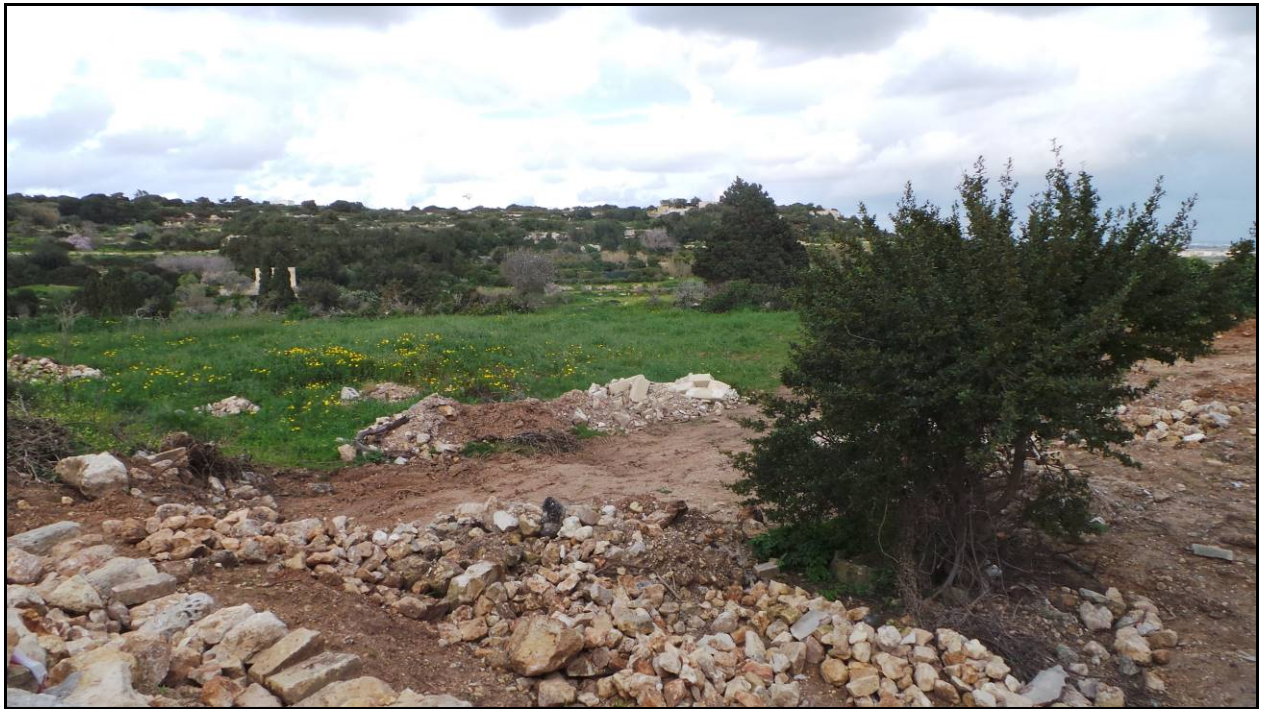
Figure 11: Area designated for Action C5. Dominant species included Crown Daisy (*Glebionis coronarium*), White Mignonette (*Reseda alba*), and Alexanders (*Smyrnum olusatrum*).

Macrophyte assemblages in land indicated for Action C5 was dominated by ruderal species and segetal species, and was consistent with assemblages of disturbed agricultural margins (Figure 11). The most abundant species in these areas included Crown Daisy (*Glebionis coronarium*), Cape Sorrel (*Oxalis pes-caprae*), Friar's Cowl (*Arisarum vulgare*), Alexanders (*Smyrnum olusatrum*), Giant Fennel (*Foeniculum vulgare*), Mallow (*Malva* sp.) and White Mignonette (*Reseda alba*). The species noted in the designated areas at the time of survey have a widespread distribution in the Maltese Islands, and are not protected by legislation.
